WHITE PLAINS RESERVOIR DAM NO. 2

WESTCHESTER COUNTY, NEW YORK  
INVENTORY NO. N.Y. 24

PHASE I INSPECTION REPORT  
NATIONAL DAM SAFETY PROGRAM

JULY 1981

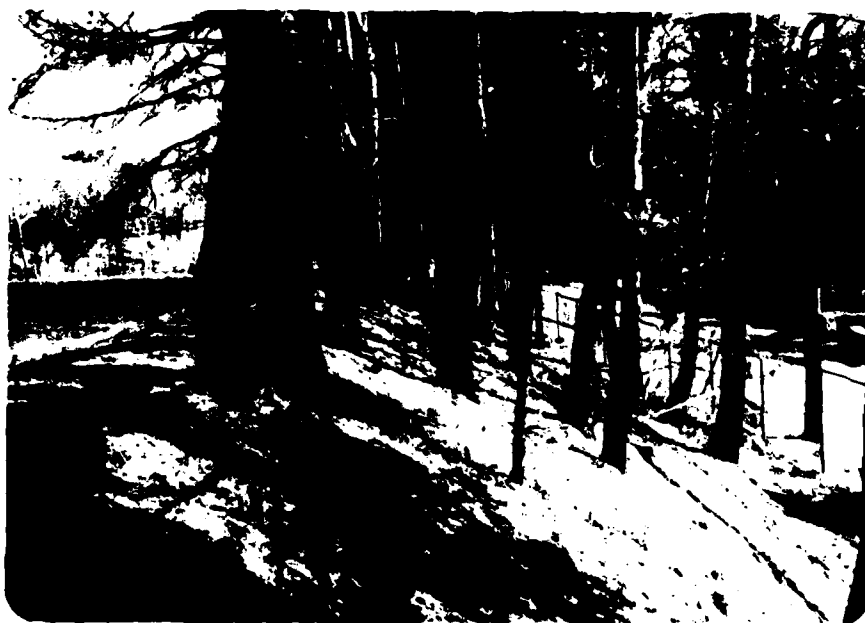
5. VIEW OF DOWNSTREAM FACE TOWARDS LEFT  
ABUTMENT (NOTE: LARGE TREES)

2. All small trees, dead large trees and large trees located near the crest should be cut down and removed. Larger trees on the downstream slope should be inventoried and their condition monitored. If one of these trees dies it should be cut down and the area around the stump should be monitored for the development of seepage. All depressions existing or resulting from the removal of trees should be backfilled with compacted material.

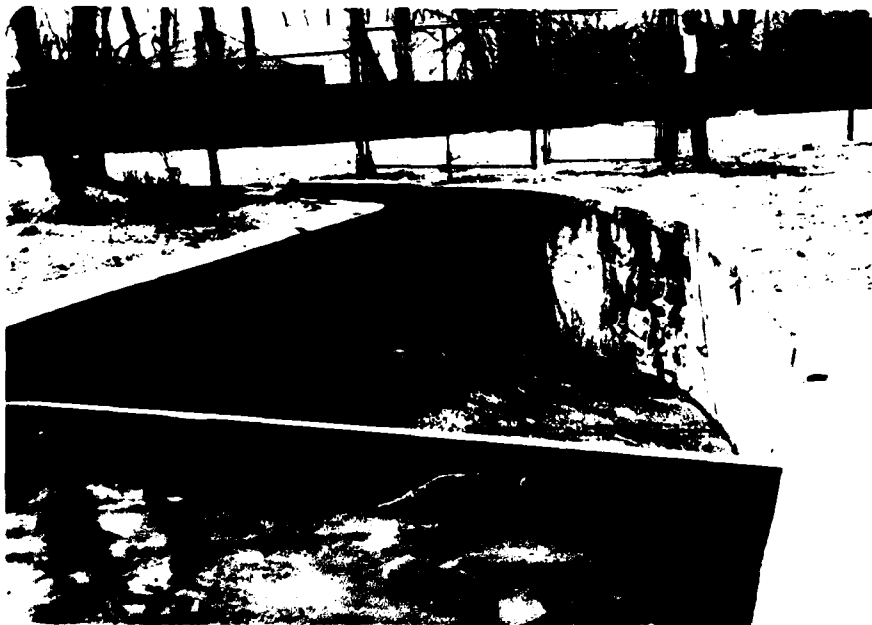
and the channel walls displayed a considerable amount of ice damage. The downstream channel was free of debris and in good condition with the exception of the training walls where the concrete covering the stone is in need of repair (See Photograph 9). The remainder of the tailrace channel which passes along the right flank over the top of the dam is in good condition.

9. VIEW OF SPILLWAY LOOKING DOWNSTREAM  
(NOTE: DETERIORATED CONCRETE IN WALLS)

4. The concrete on the spillway training walls should be repaired and the debris in the approach channel cleaned out.
